BBULL IMAGE BK
Threaded Flange Inspection

BBULL IMAGE 120 (Threaded flange)

Multi-camera system for detecting faults on aluminum ROPP screw caps

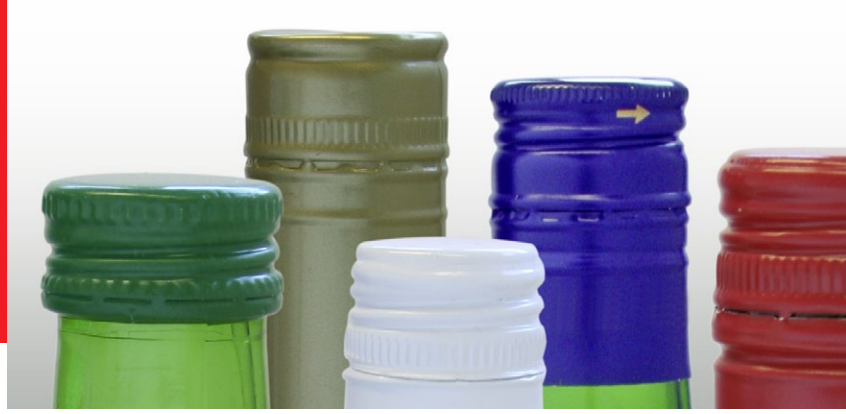
- Multi-camera system (3 CMOS cameras with resolution up to 1936x1216 pixels per camera)
- closure is 3x shown in profile
- each image is checked for sufficient thread depth, insufficient threads are in the image as fault
 - adjustable thread depth > 0.6 mm
- faulty bottle will be rejected with following rejection system

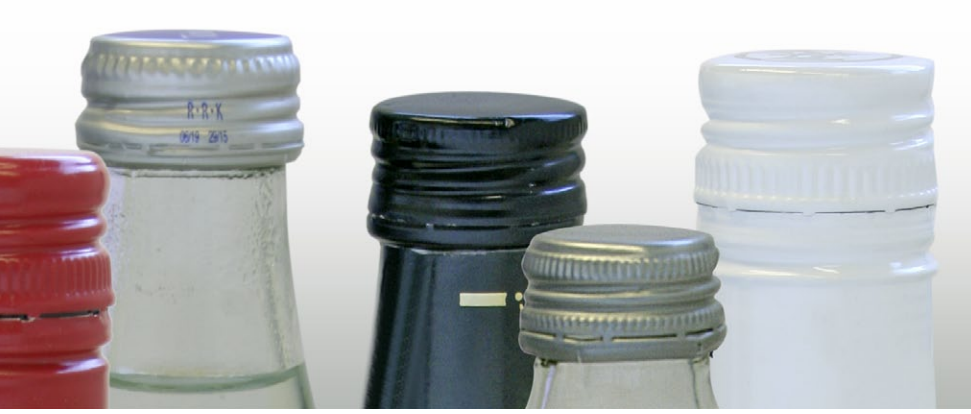
BBULL IMAGE 360 COMPACT (Threaded flange)

Multi-camera system for detecting faults on aluminum ROPP screw caps

- Multi-camera system (4 CCD cameras with resolution up to 2452x2056 pixel per camera)
- closure will be 4x recorded and generates a 360° complete picture in front view
- each image is checked for sufficient embossing depth, insufficient embossings are in the image as faulty displayed
→ adjustable embossing depth > 0.6 mm
- faulty bottle will be rejected with following rejection system
